PARTS LIST

BPW M.G. - Rev. 0a (05/03)

Troubleshooting and Maintaining the Sloan Slimline[®] Bedpan Washer

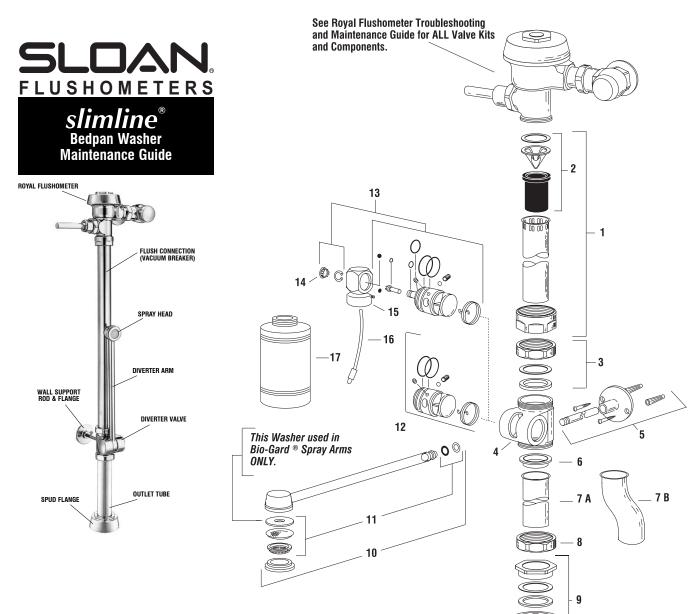
| 1. 2. | 0393009 0393008 0393029 3323182 | | 11/2" x 211/2" CP Vacuum Breaker 11/2" x 131/2" CP Vacuum Breaker (ADA height) 11/2" x 211/2" CP Vacuum Breaker w/2" Offset Vacuum Breaker Repair Kit |
| 2. 3. | 0306093 | V-057-A F-2-A | 11/2" Slip Joint Coupling |
| 4. | 0309001 | DV-1 | Diverter Valve Body |
| 5. | | DV-1001-A | Wall Support Kit |
| 6. | 0309027 | | Outlet Tube Gasket |
| 7A. | 0309029 | | Outlet Tube |
| 7B. | 0396525 | | Outlet Tube w/11/2" Offset |
| 8. | 0306045 | F-2 | 11/2" Coupling Nut |
| 9. | 0306146 | F-5-A | 1 ¹ /2" Spud Coupling Assembly |
| 10. | 3309044 | DV-32-AA | Spray Arm Replacement Kit |
| 11. | 3309032 | DV-1007-A | Spray Arm Repair Kit |
| 12. | 3309037 | DV-1003-A | Pivot Replacement Kit |
| 13. | 3309036 | DV-1002-A | Deoseptic Pivot Replacement Kit |
| 14. | 0309024 | DV-21 | Plug Button |
| 15. | 0309033 | DV-33-A | Swivel & Ball Check Assembly |
| 16. | 0309036 | DV-36-A | Aspirator Tube Assembly |
| 17. | 0309018 | DV-29 | Deoseptic Solution Bottle |
